**DTB**

Date: July 11, 2008  
Order No.: P-B-54.21/197a  
Supersedes: P-B-54.21/197 dated May 22, 2008  
Group: 54

**SUBJECT: Model 204.054/056/081**  
**Vehicle Does Not Start, No Communication with Star Diagnosis, Power Outlets Not Functioning**

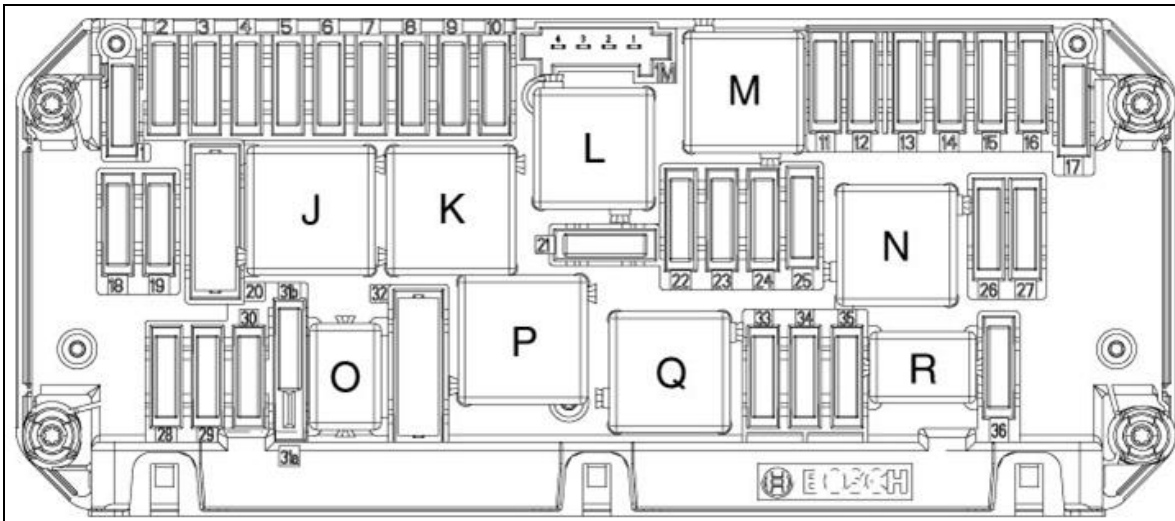
Figure 1

If you receive customer reports in the above model vehicles with any of the below symptoms, this may be due to a non functional relay in the driver side or rear SAM.

For vehicles in VIN range F057431 to F162917 or R004400 to R029520:

- Vehicle does not start
- Wipers not operating correctly
- No communication with Star Diagnosis
- Message in the instrument cluster display indicating brake lamp fault
- Fault codes B212172, B215F71, B215F72, or B212171 "Circuit 15R malfunction" present in the driver side SAM

To resolve, replace the nonfunctional relay in the front SAM:

- Terminal 15 relay (Figure 1, Slot J)
- Terminal 15R relay (Figure 1, Slot K)
- Terminal 87 relay (Figure 1, Slot N)
- Secondary air injection pump/oil cooler relay (Figure 1, Slot P)

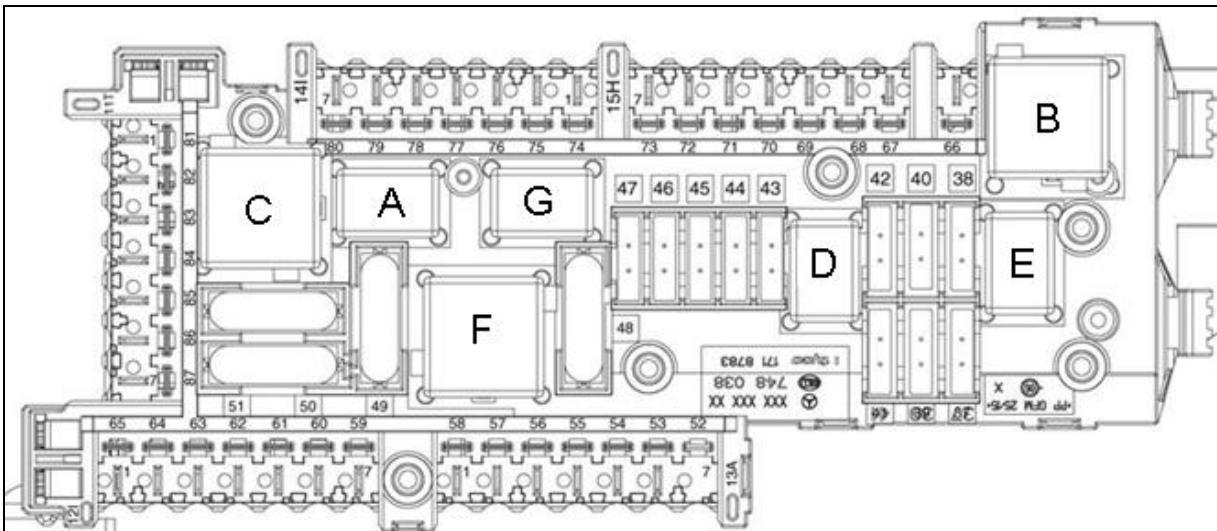
Figure 2

For vehicles in VIN range F130373 to F198707 or R020785 to R039070:

- Vehicle does not start
- Power outlet inoperative
- TeleAid inoperative

To resolve, replace the nonfunctional relay in the rear SAM:

- Terminal 15 relay (Figure 2, Slot A)
- Fuel pump relay (Figure 2, Slot D)
- Terminal 15R relay (Figure 2, Slot G)
